Shoreline Situation Report
CITY OF HAMPTON, VIRGINIA

Chesapeake Research Consortium Report Number 11

Special Report In Applied Marine Science and Ocean Engineering Number 76 of the

VIRGINIA INSTITUTE OF MARINE SCIENCE

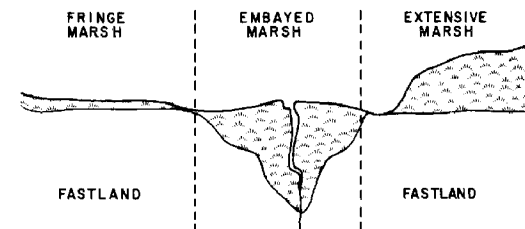
Figure 1B

The physiographic character of the marshes has also been separated into three types (see Figure 1B). Fringe marsh is that which is less than 400 feet in width and which runs in a band parallel to the shore. Extensive marsh is that which has extensive acreage projecting into an estuary or river. An embayed marsh is a marsh which occupies a reentrant or drowned creek valley. The purpose in delineating these marsh types is that the effectiveness of the various functions of the marsh will, in part, be determined by type of exposure to the estuarine system. A fringe marsh

A generalized illustration of the three different marsh types.

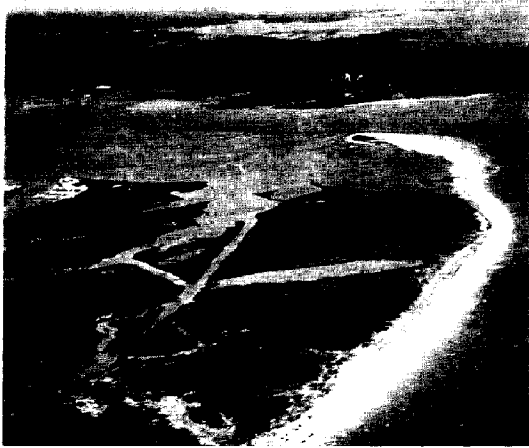
Figure 2

Figure 2: Northend Point and the Back River from near Grand View. The dune area is the site of an experimental grass planting. Most of the marsh is city owned.

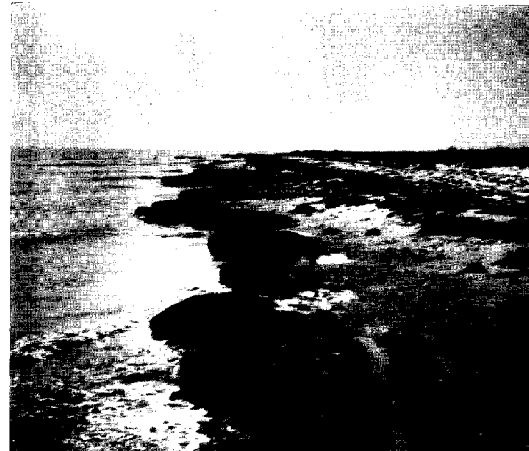
Figure 5

Figure 5: The beach north of Grand View. As the beach retreats over the marsh, peat blocks erode out of the thin beach face.

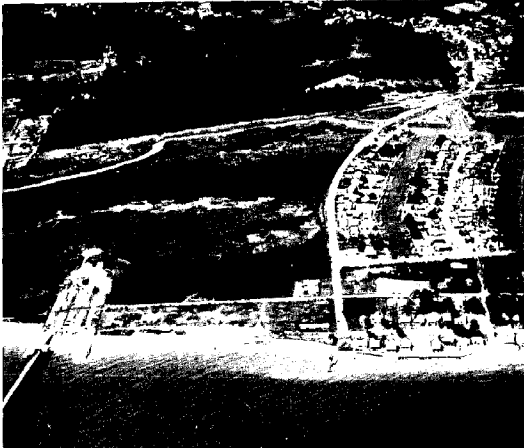
Figure 7

Figure 7: The Grand View section of Hampton.

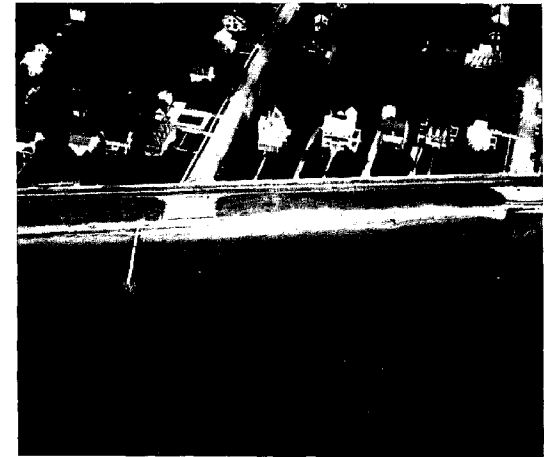
Figure 8

Figure 8: The Wythe area of Hampton on Hampton Roads. Most of the shoreline of this segment has been bulkheaded to the detriment of the beach. A better beach might be established through a program of artificial nourishment.

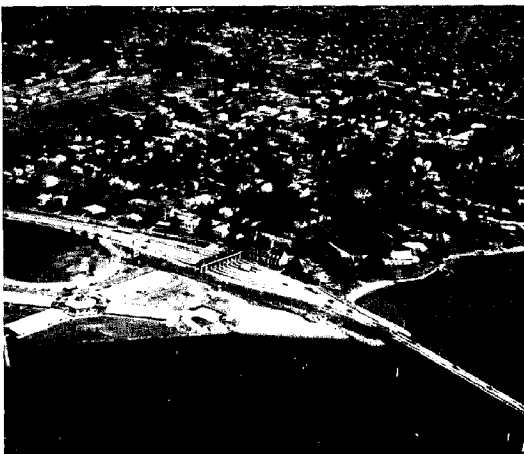
Figure 9

Figure 9: Strawberry Banks and the Hampton Roads Bridge Tunnel.

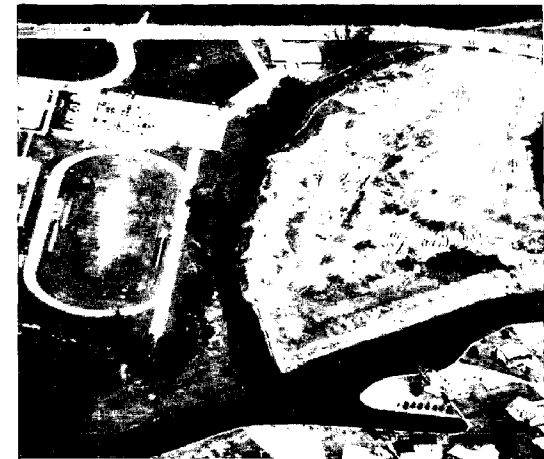
Figure 10

Figure 10: Hampton Creek near Syms Junior High School. The area is an example of dredge and fill canals dug into existing small creeks and upland areas to produce waterfront property.
